# Manhole Inspection Summary

Manhole # S71A1\_008MH

Insp Date: **2/12/08 12:28 PM**

**Location** Address: **6607 Pine Ave.**

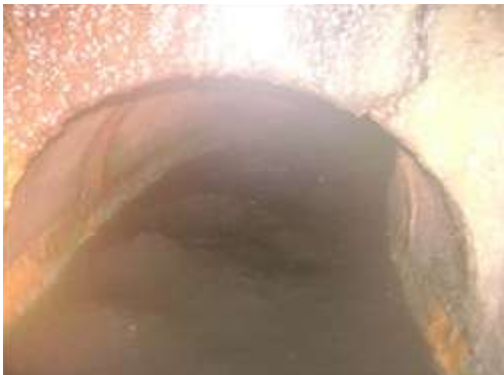
Defect 2

Cracked pipe seal/barrel wall 2:00  
incoming 6 o'clock

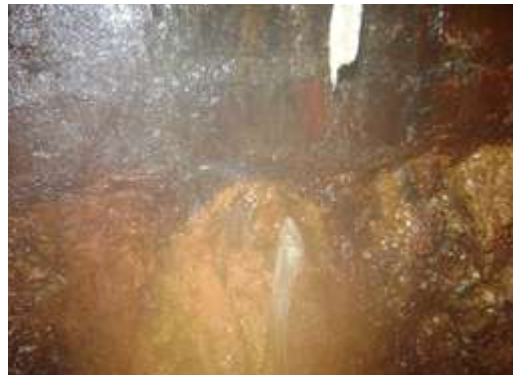
Defect 1

Comments **AT APPROXIMATELY 26FT DOWN AT THE 3'O'CLOCK BARREL POSITION, THERE IS A HOLE IN THE WALL. THE HOLE IN THE WALL HAS A HIGH FLOW OF WATER. 3 O'CLOCK DROP CONNECTION IS CLOGGED.**

Hole, 26ft. down at 3'oclock position

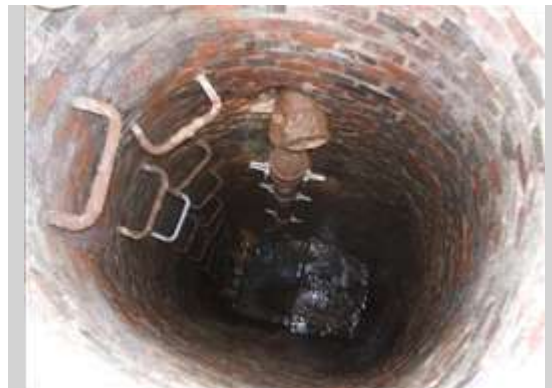
Pipe In @ 6 O'Clock

Drop: **Inside** Rod Only  
Angled: **Yes** Reading: **27.17** (ft.)  
Inv Depth: **27.17** (ft.)  
Drop Condition: **Open**

☒ Possible Illicit Connection

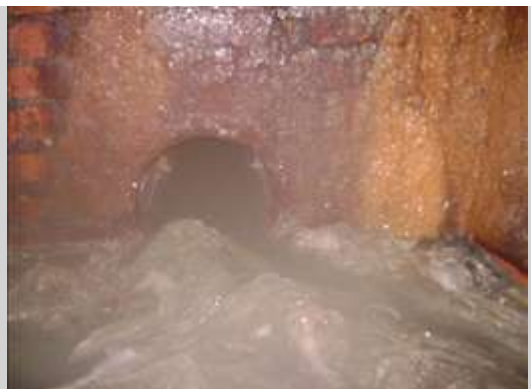
Pipe In @ 9 O'Clock

Deposits: ☐ None ☐ Mud ☐ Sludge ☐ Debris ☒ Grease

Silt Depth: **0.25** (in.) Deposits Extent: **Light**

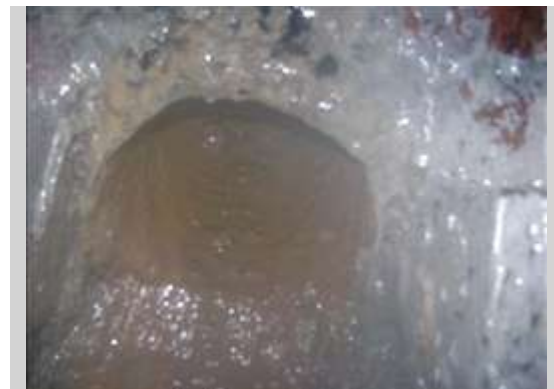
Drop In @ 9 O'Clock

Drop: **Outside** Rod Only

Drop Condition: **Clogged**
